DarkLight at ARIEL

Update July 2024

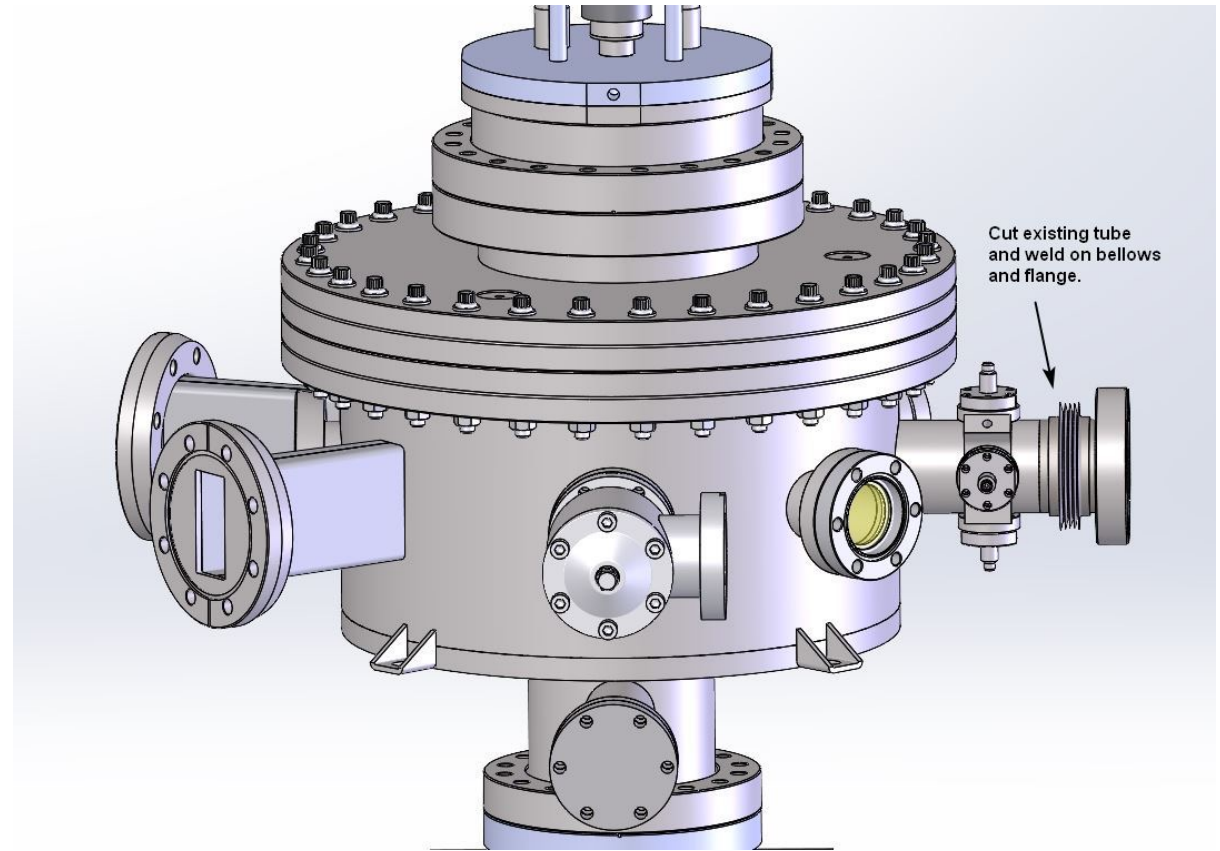
DarkLight Scattering Chamber

- Adding bellows to inlet tube to chamber.
- Bellows has been ordered and machine shop is ready to modify chamber.

- Upcoming steps for DarkLight effort includes:
 - Modifying scattering chamber inlet port for bellows addition.
 - Leak check of scattering chamber after modifications for bellows.
 - Fabricate stands for scattering chamber and dipole arms.
 - Modify magnets upon arrival.
 - Leak check dipole chamber upon its arrival.
 - Order all remaining hardware (mostly bolts, nuts, and gaskets)
 - Assemble complete system, leak check, and survey.

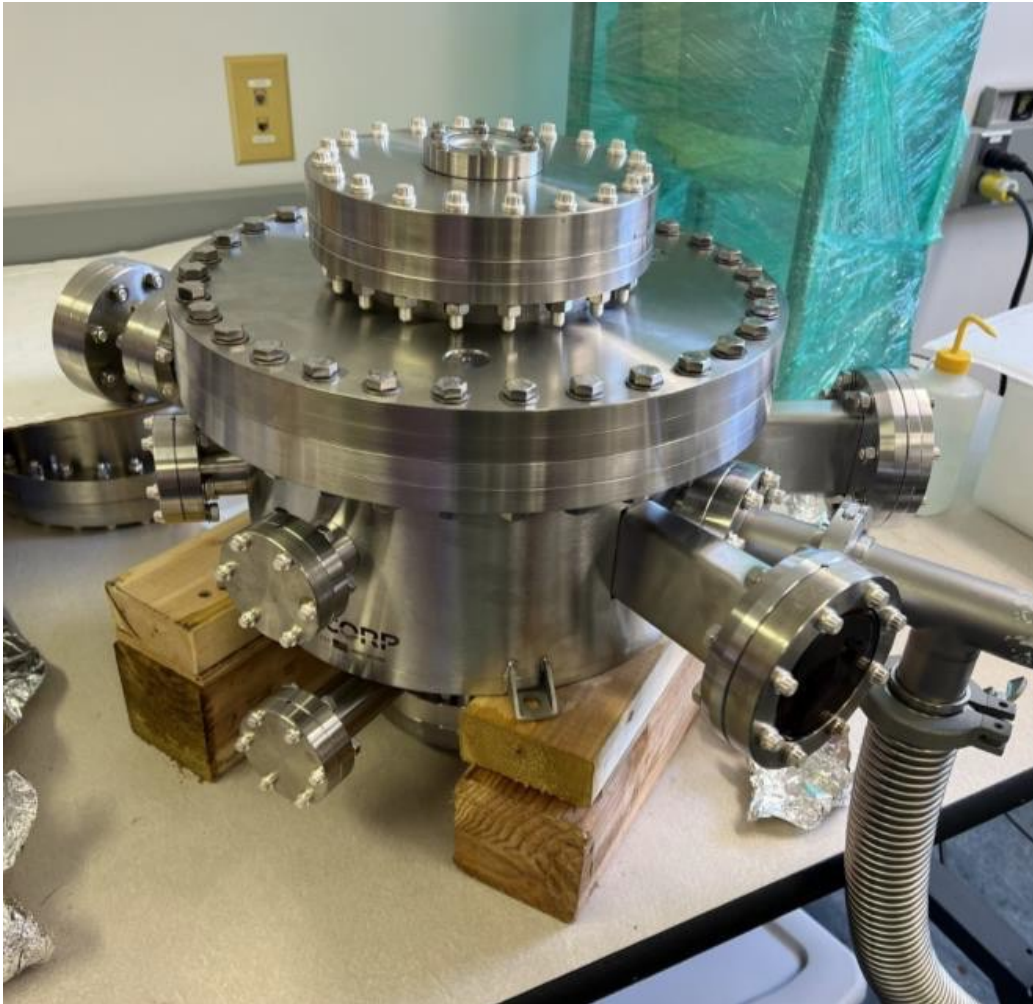
Scattering Chamber

Scattering chamber delivered and leak checked.

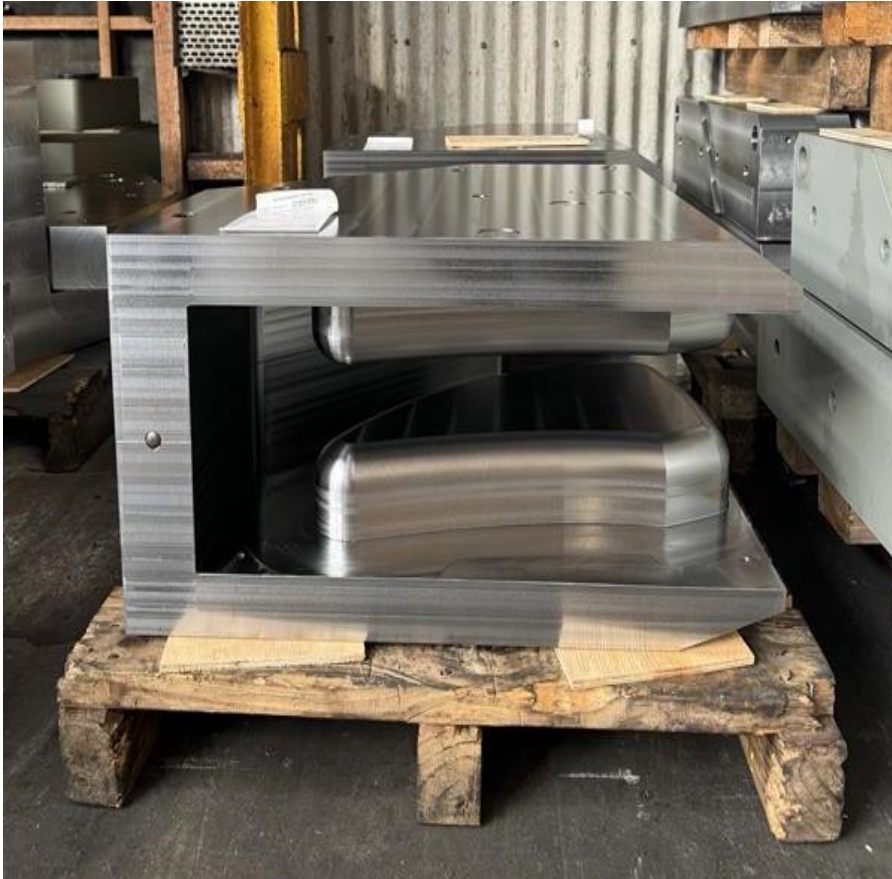
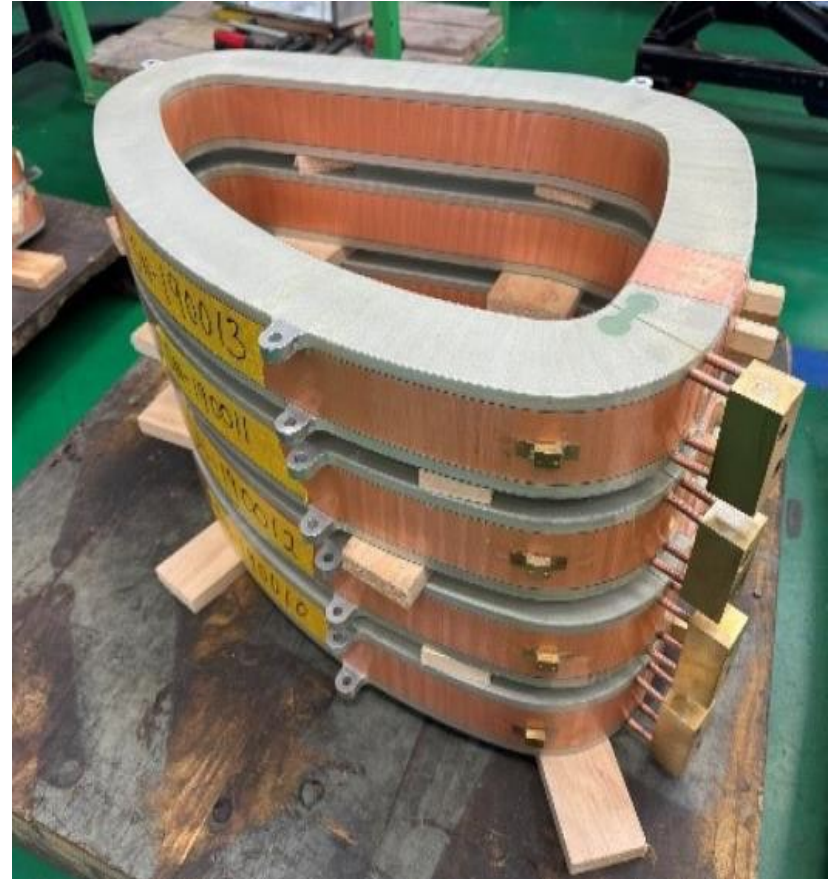
- Dipole Magnets are finished. We are currently working on getting them shipped to Bates.

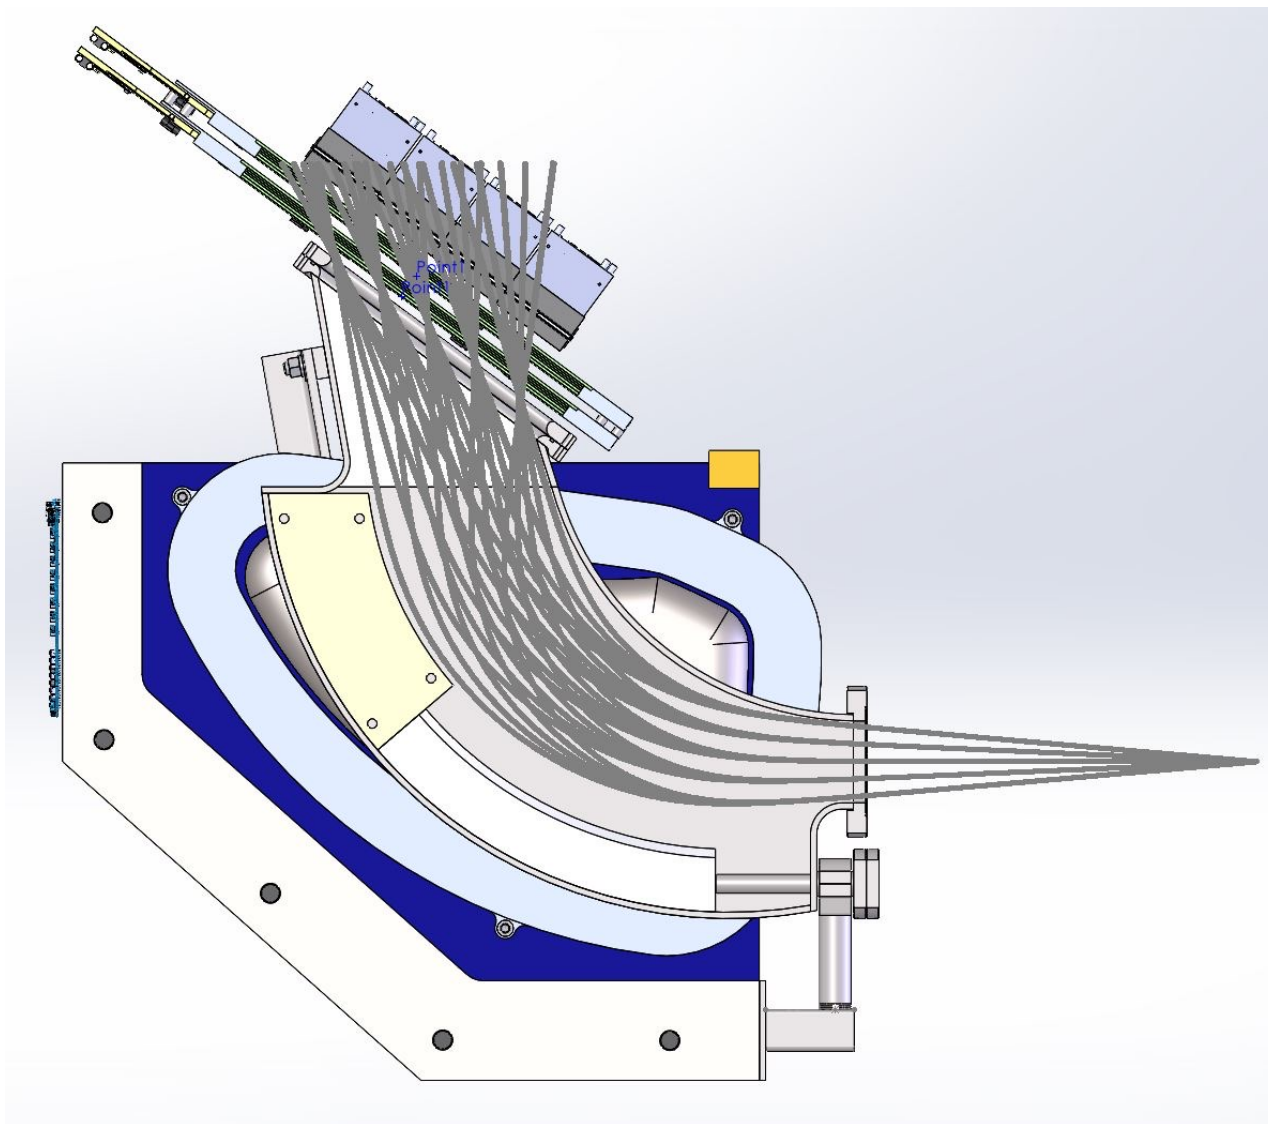
Section View of Electron arm w/ latest PEEK design

Modified
PEEK
shielding
design for
electron arm

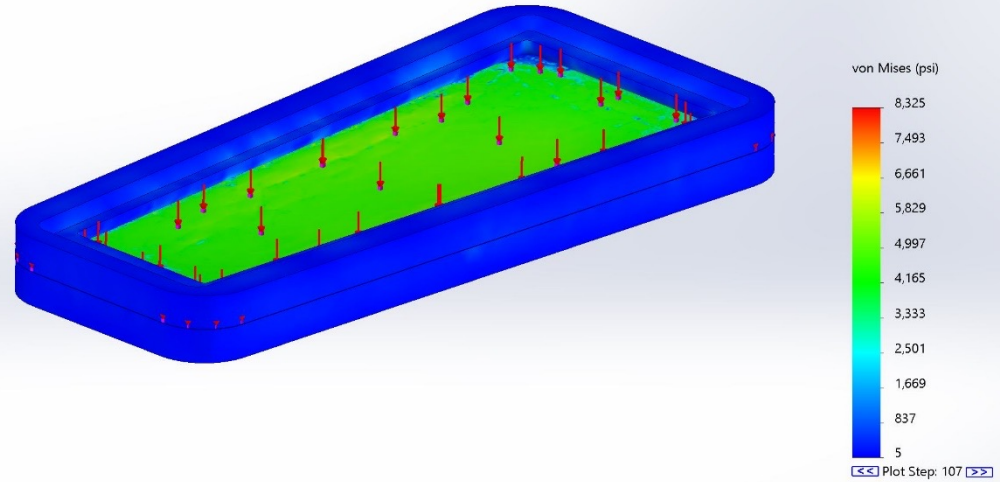
Thin window FEA analysis

Stress levels above yield (expected) but below ultimate strength of material.

- Testing on windows was carried out by hydro-testing.
- Actual deflections were less than FEA results.
- Testing demonstrated a safety factor of 4 before failure.
- Will show video of a window test.

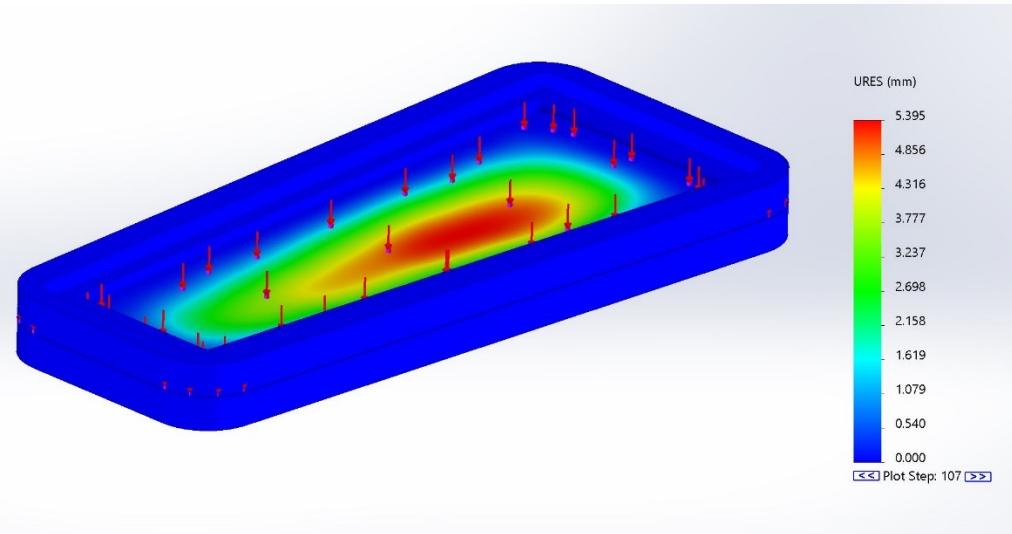
The analysis shows approx. 5.4mm of displacement.
