Status update

ER2 arrival

ER2 recap

First wafer probing tests

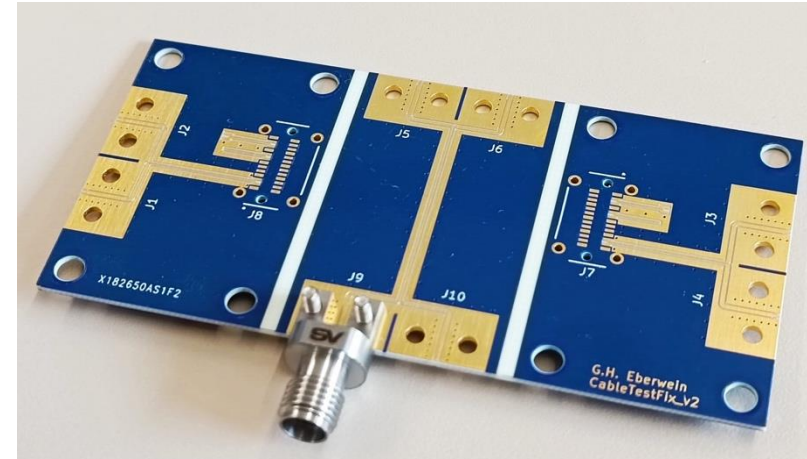
First measurements on 5x babyMOSAIX

- Power up global services
 - Exercise node slow control
 - Service nodes
- Power up global analog/digital GAVDD/GDVDD
 - Core slow control responsive
 - Tiles can be powered up – successful (so far 100%)
 - Can connect local analog monitoring to analog out and read local tile supplies
- Metal stack paper accepted – waiting for proof
- Cable high-speed test fixture arrived

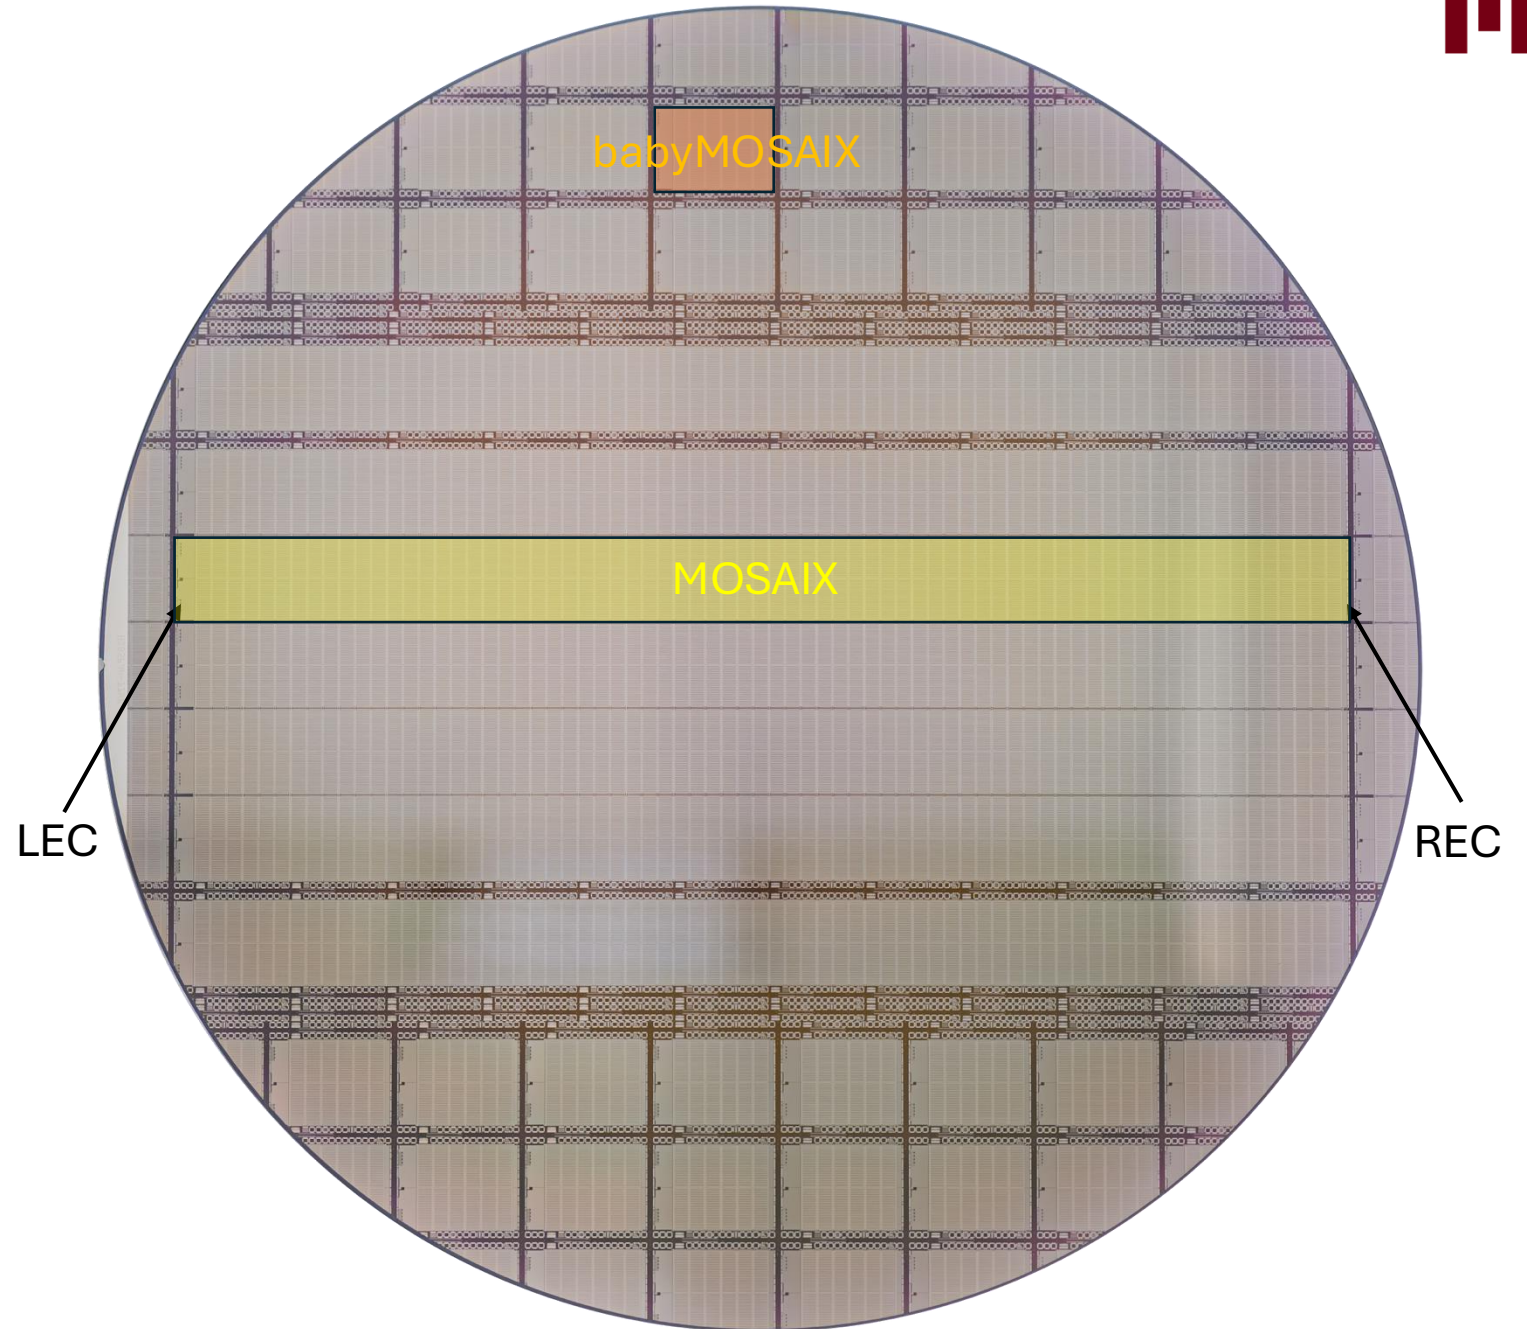
- 5x MOSAIX
- 20x babyMOSAIX
- +50x chiplets

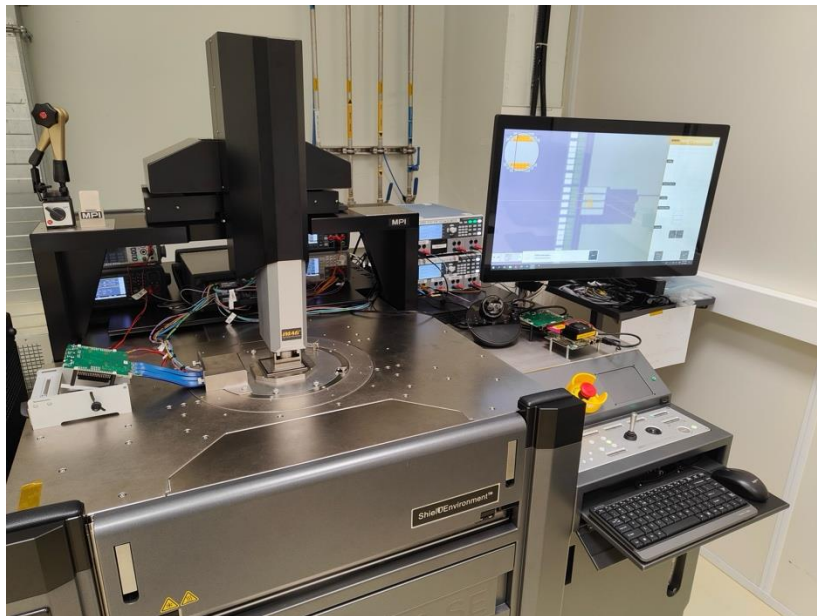
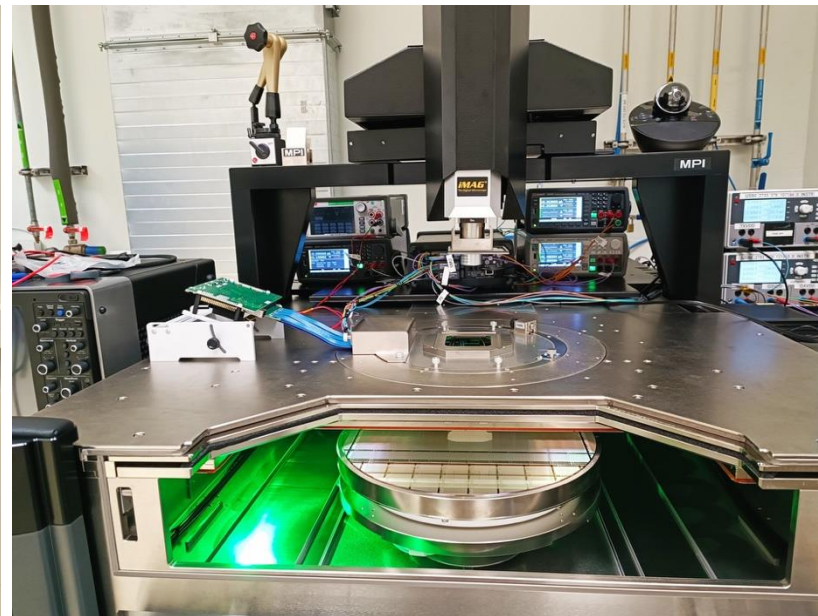
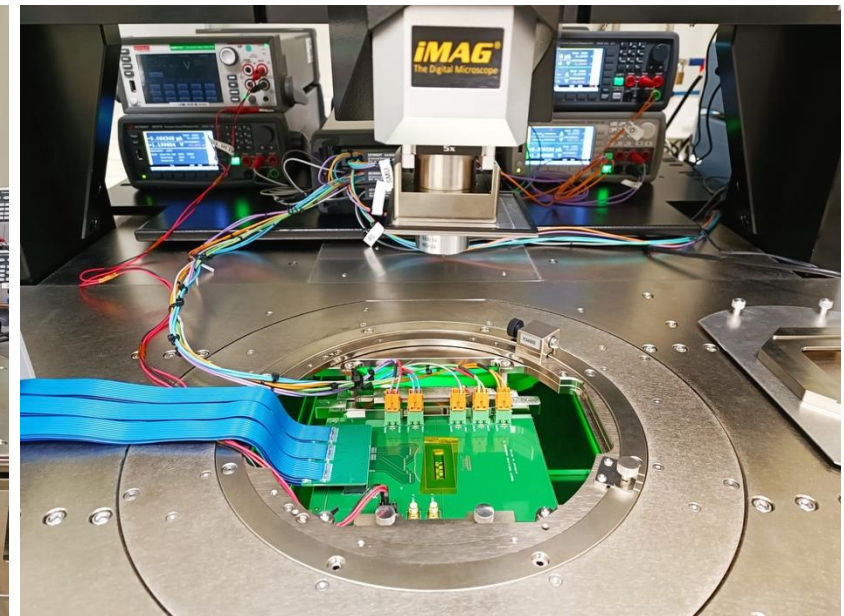
- Day 1 readiness for tests – large effort by ITS3 team (SW/FW/HW)
- Cantilever probecard (low speed) installed in MIT prober, only setup used for first tests
 - Vertical probecard (high-speed) expected next week

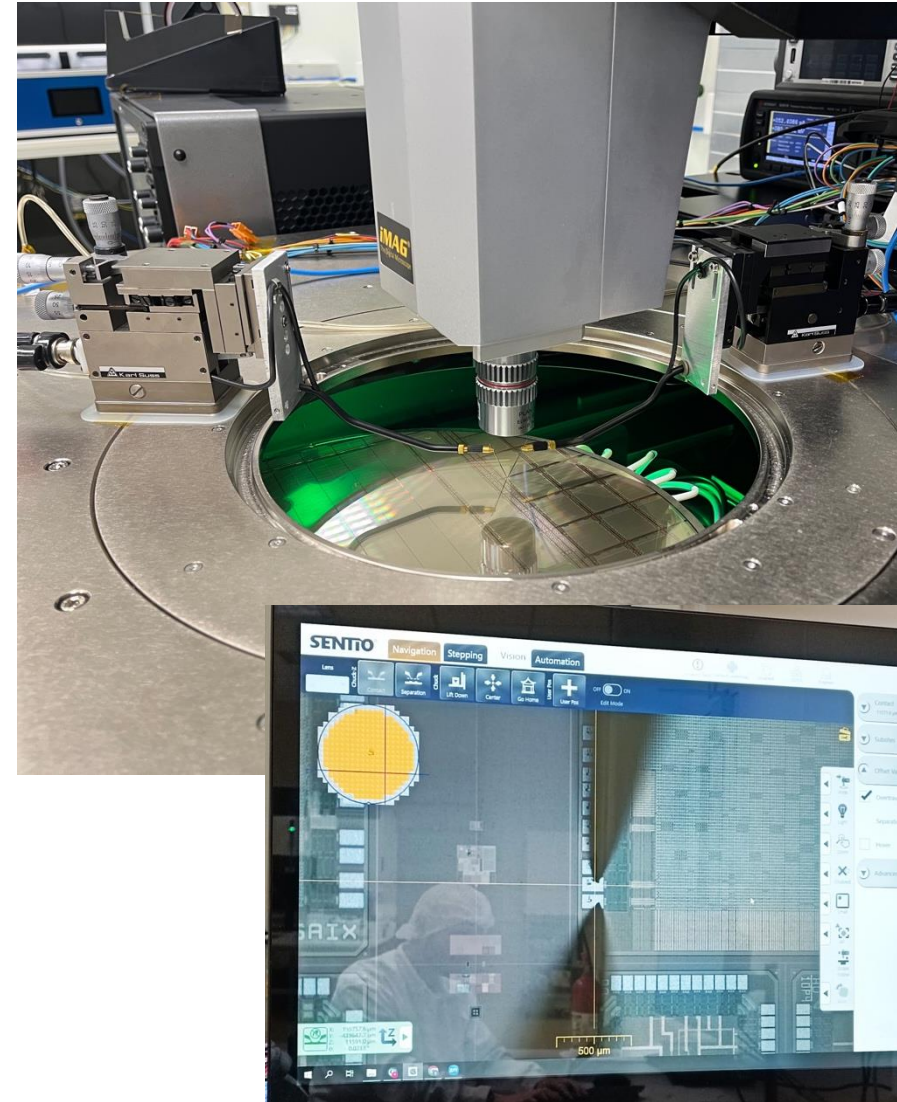
Impedance tests and debugging

- First tests showed concerning GSVDD-GSVSS short
 - Blocked any other tests in sequence
- Immediate debugging needed:
 - Nets probed with adapted micromanipulators
 - No shorts on chip!

- Move to single needles/manipulators – not compatible with the wafer prober
 - Made metal adapter plates for the micromanipulators in the workshop
- Wednesday installed the micromanipulators to probe single nets

- Confirmed that there is NO short on the chip services supply
 - Huge relief
 - Potential culprit – Probecard pinout (i.e. how the needles were soldered to the pcb)

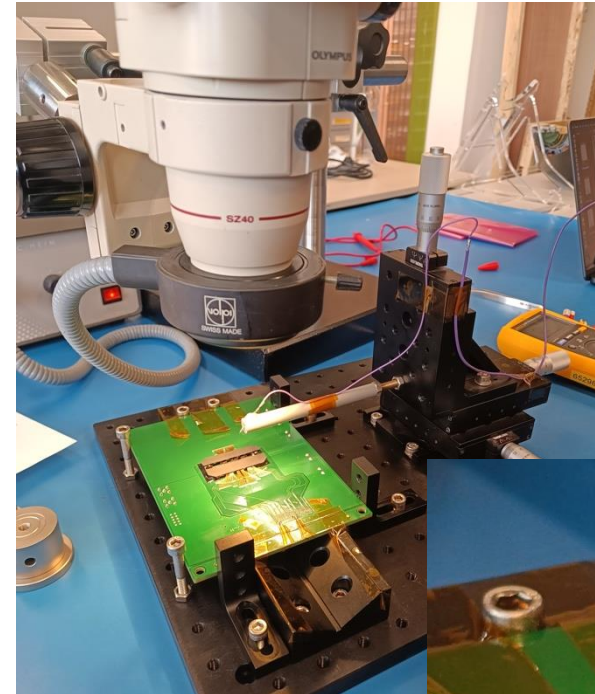
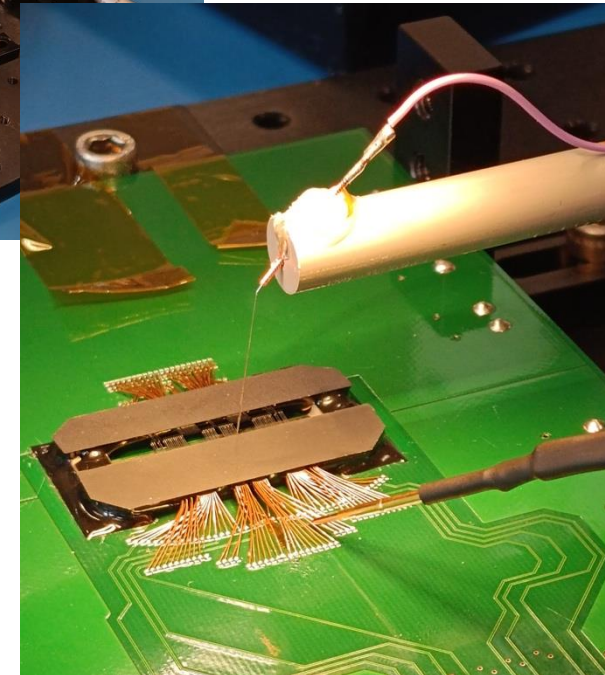
Impedance tests and debugging

- First tests showed concerning GSVDD-GSVSS short
 - Blocked any other tests in sequence
- Immediate debugging needed:
 - Nets probed with adapted micromanipulators
 - No shorts on chip!
 - Made ad-hoc test fixture for probing the probecard
 - Confirmed needle swaps
 - Reworked @CERN
 - Debugged and patched in ~ 4 days

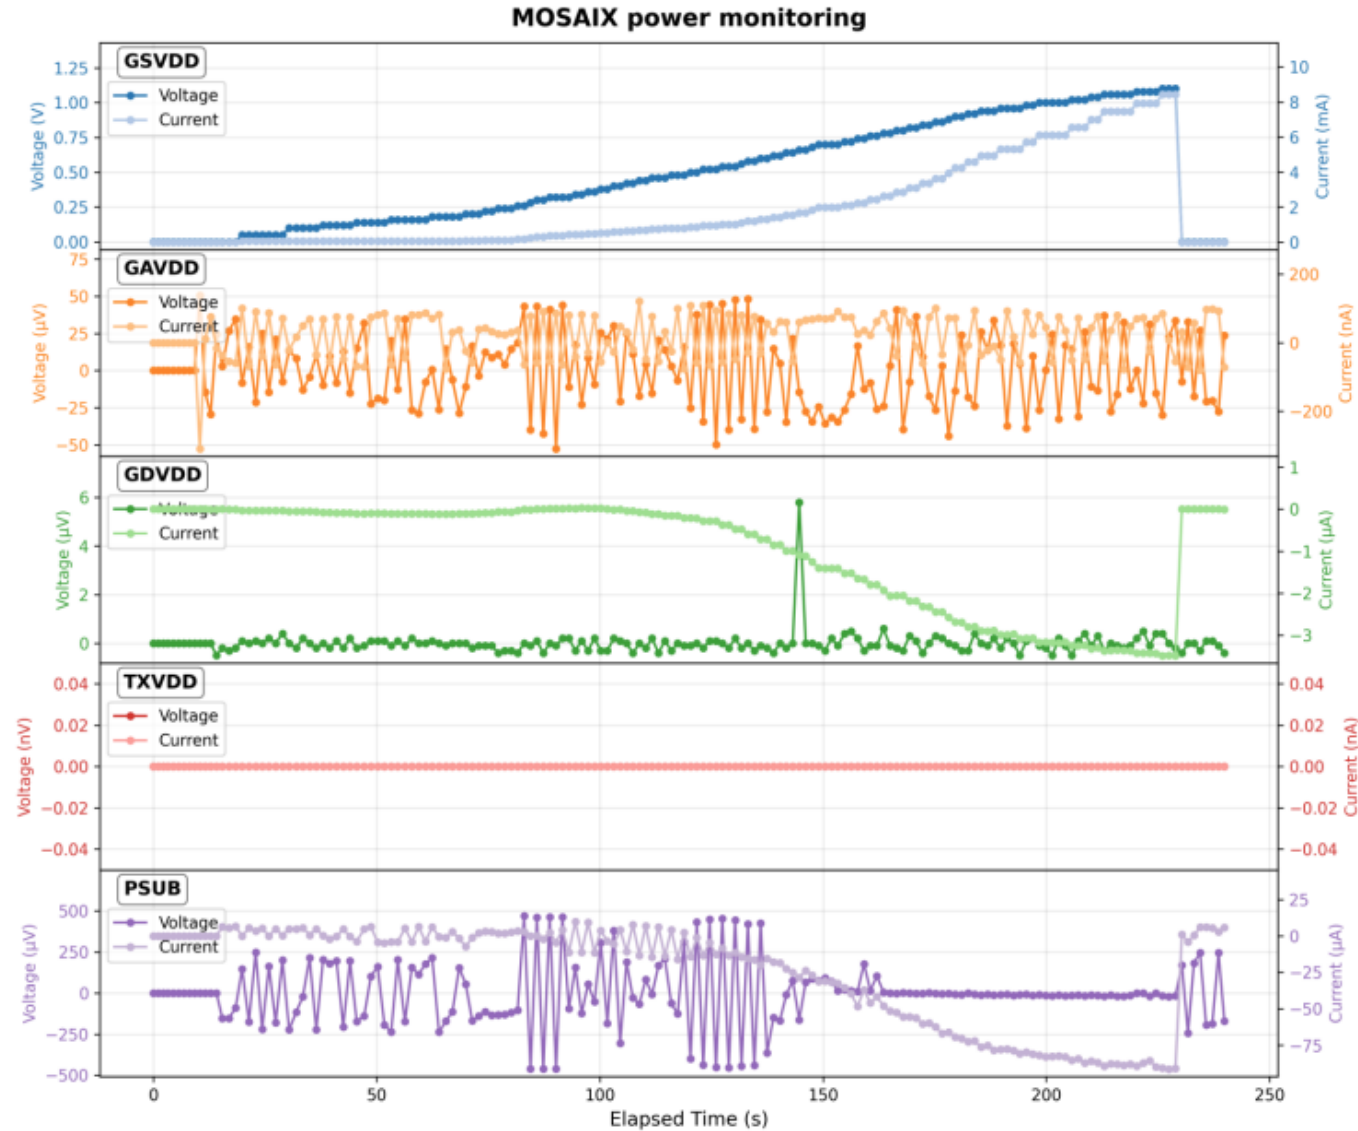
Power ramp-up – global services

- Global services ramped up
 - Reasonable current consumption
- Now one can talk to the chip
 - Reading/writing to services slow control endpoints confirmed
 - Debugged a FPGA locking issue, stable afterwards

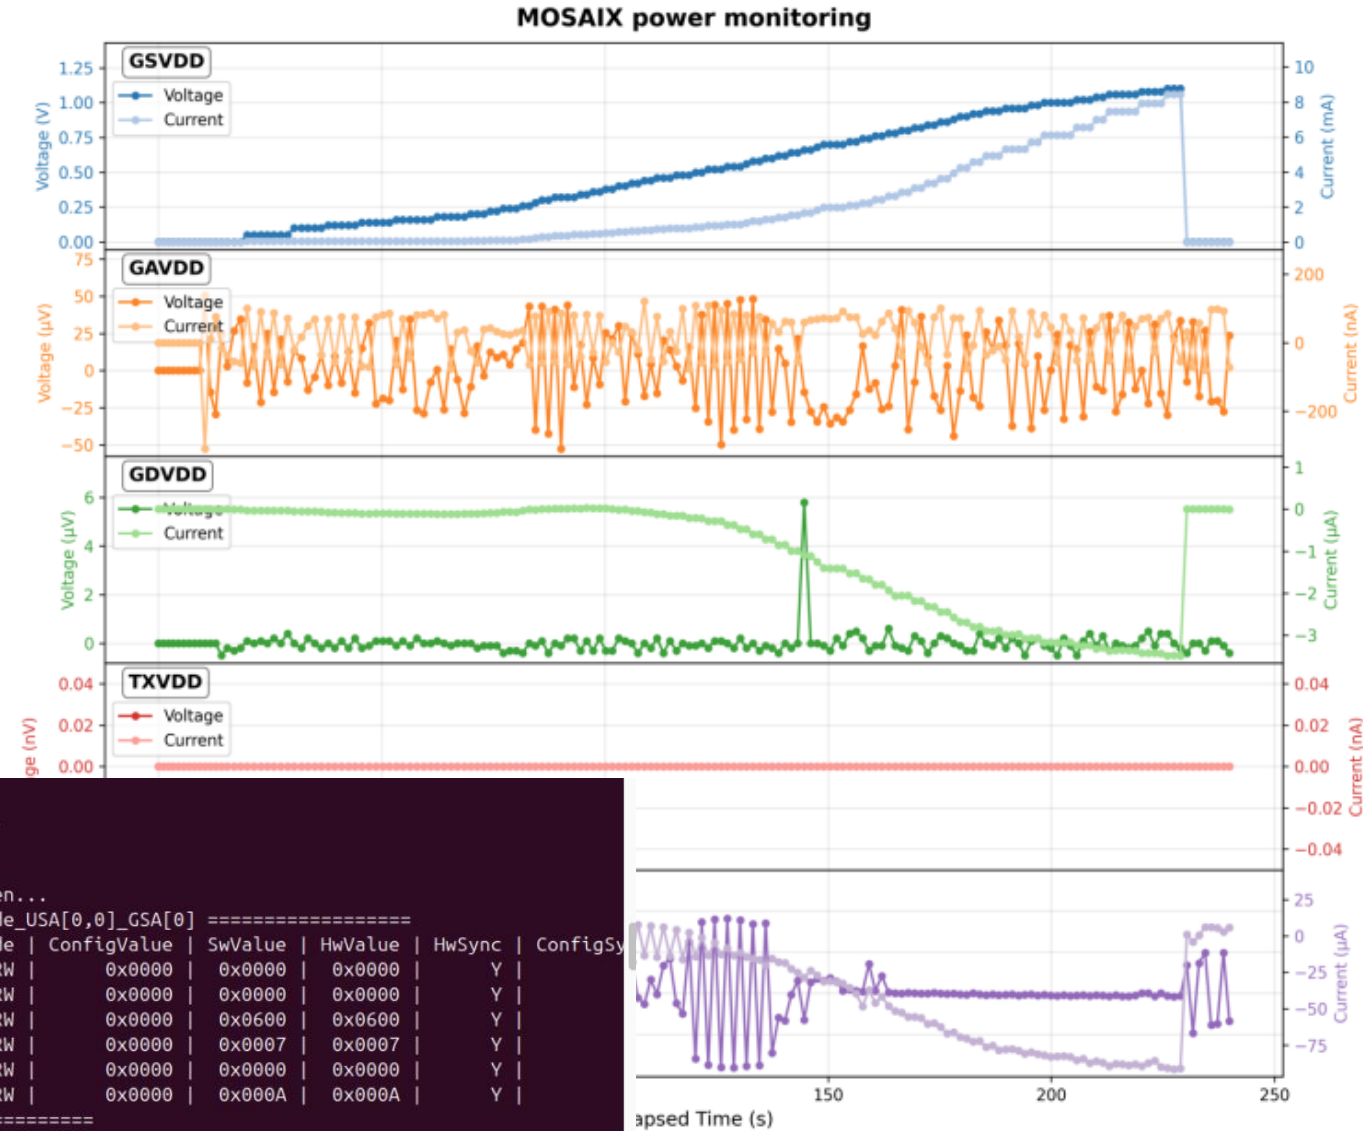
Power ramp-up – global services

- Global services ramped up
 - Reasonable current consumption
- Now one can talk to the chip
 - Reading/writing to services slow control endpoints confirmed
 - Debugged a FPGA locking issue, stable afterwards
- Service nodes can be reached

```
mosaix[0]:sn-USA[0,0]> read-all-registers
INFO [2026-02-25 14:48:10.186]: Reading all readable registers from hardware...
INFO [2026-02-25 14:48:10.188]: Read 6 readable registers from hardware
mosaix[0]:sn-USA[0,0]> dump-registers
INFO [2026-02-25 14:48:12.081]: Dumping ServiceNode USA[0,0] registers to screen...
INFO [2026-02-25 14:48:12.081]: ===== Register Dump for ServiceNode_USA[0,0]_GSA[0] =====
INFO [2026-02-25 14:48:12.081]: Name | Address | Mode | ConfigValue | SwValue | HwValue | HwSync | ConfigSy
INFO [2026-02-25 14:48:12.081]: TILE_POWER_SWITCHES_CFG | 0x0000 | RW | 0x0000 | 0x0000 | 0x0000 | Y |
INFO [2026-02-25 14:48:12.081]: ANALOG_MONITORING_CFG | 0x0001 | RW | 0x0000 | 0x0000 | 0x0000 | Y |
INFO [2026-02-25 14:48:12.081]: SBB_TILE_SER_CFG | 0x0002 | RW | 0x0000 | 0x0600 | 0x0600 | Y |
INFO [2026-02-25 14:48:12.081]: TILE_RESET_CONTROL | 0x0003 | RW | 0x0000 | 0x0007 | 0x0007 | Y |

INFO [2026-02-25 14:48:12.081]: GATE_SRV_NODE_ENDPOINT_RESPONSE | 0x0004 | RW | 0x0000 | 0x0000 | 0x0000 | Y |
INFO [2026-02-25 14:48:12.081]: SCRATCH | 0x0005 | RW | 0x0000 | 0x000A | 0x000A | Y |
INFO [2026-02-25 14:48:12.081]: ===== End Register Dump =====
mosaix[0]:sn-USA[0,0]> █
```

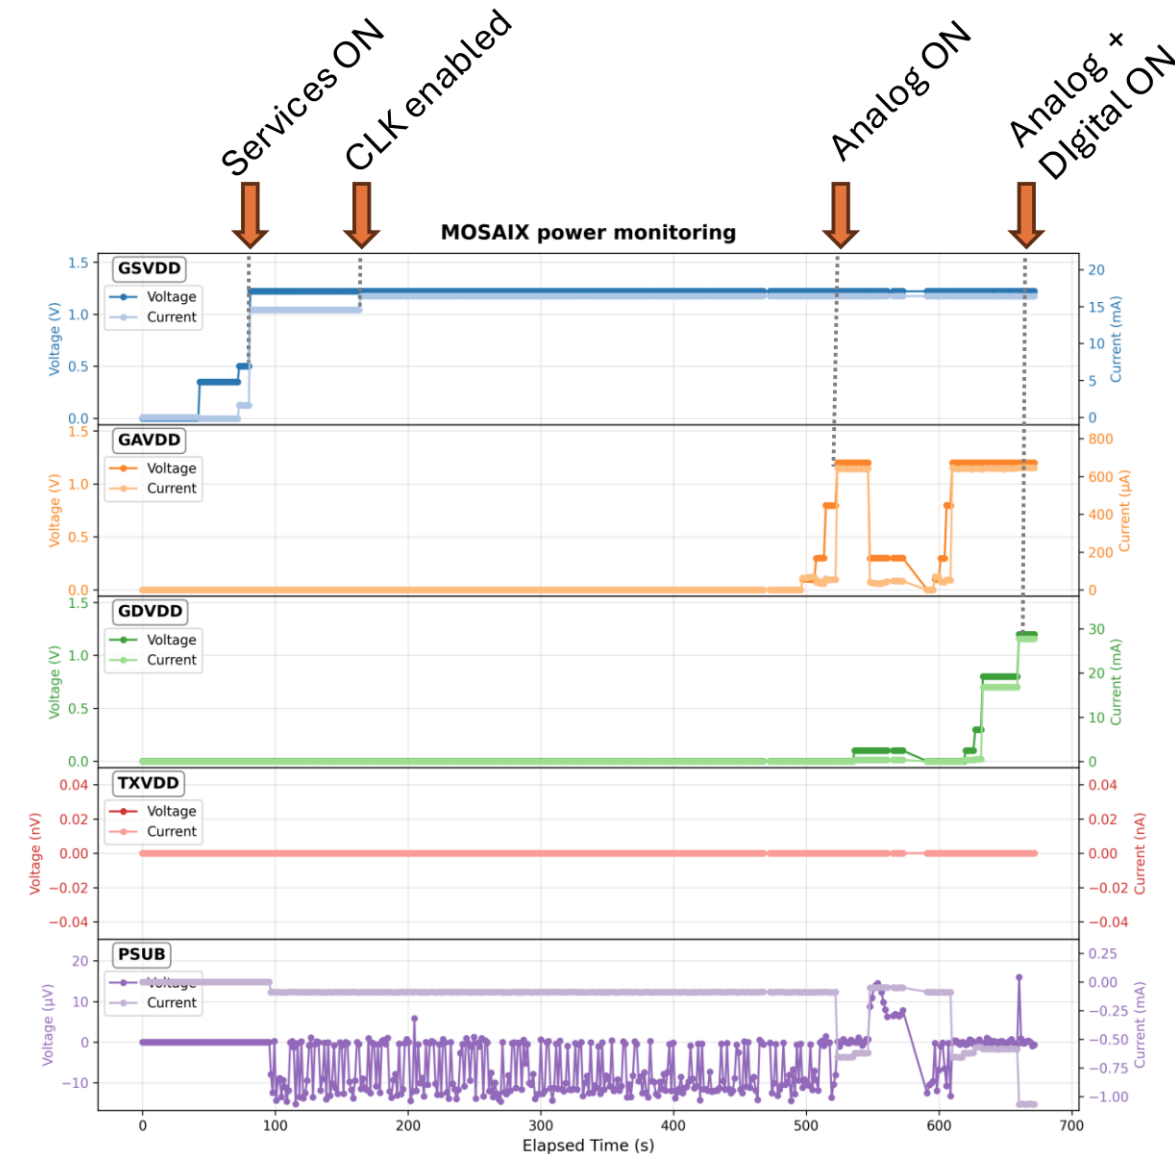
Power ramp-up – global digital/analog

- Successful power-up of the global domains (GSVDD, GDVDD, GAVDD)

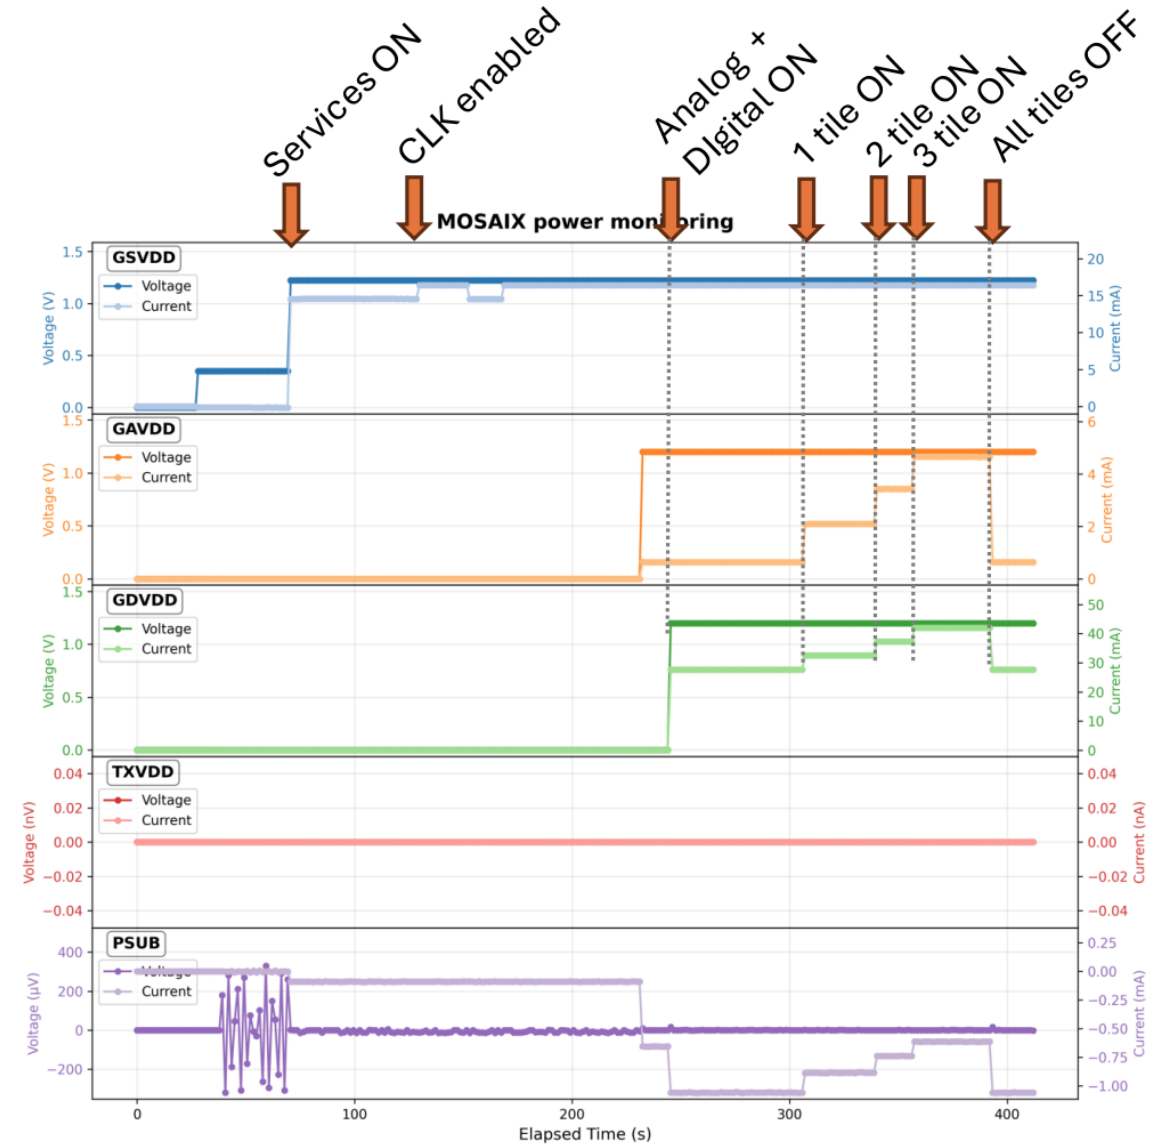
Power ramp-up – tiles

- Successful power-up of the global domains (GSVDD, GDVDD, GAVDD)
 - Now, tiles can be turned on
 - Also, all tiles powered successfully

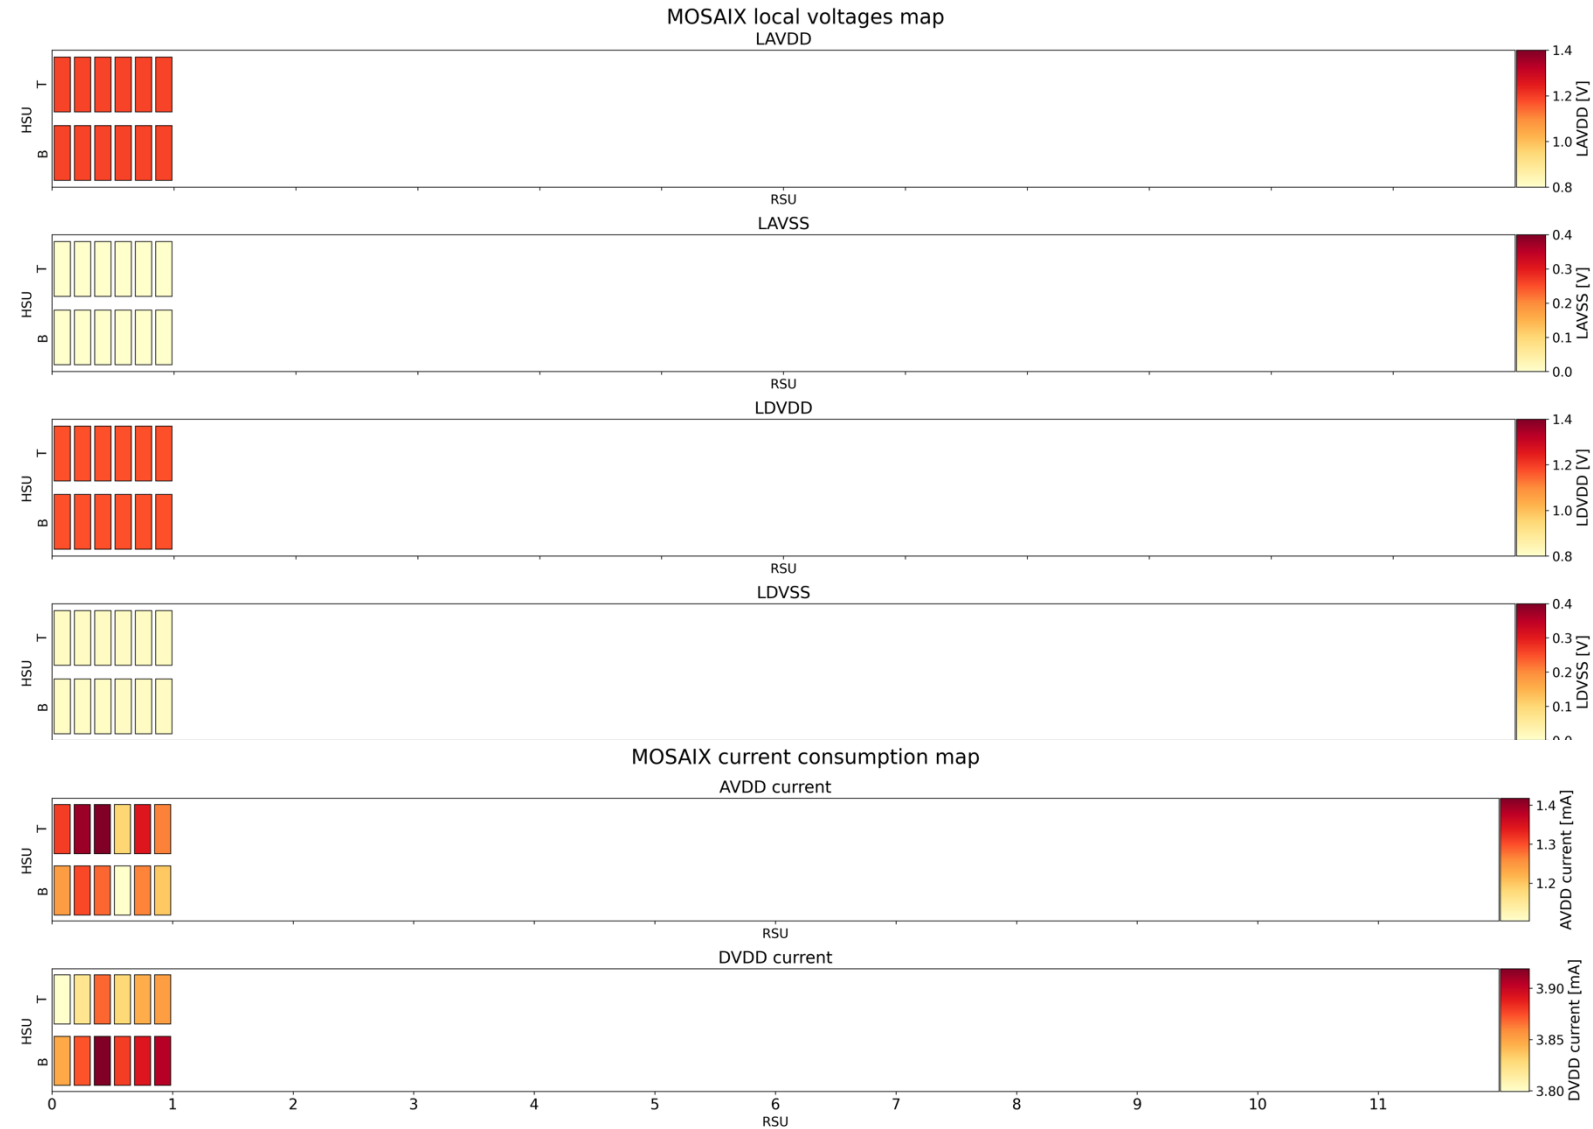
Power ramp-up – tile monitoring preview

- Tile registers read and written
- Monitoring features working
 - Measured local tile supplies and currents via analog monitoring rail
